## Electrical Signature Analysis Prevents Vertical Pump Motor Catastrophic Failure at Pumping Station

Bill Kruger

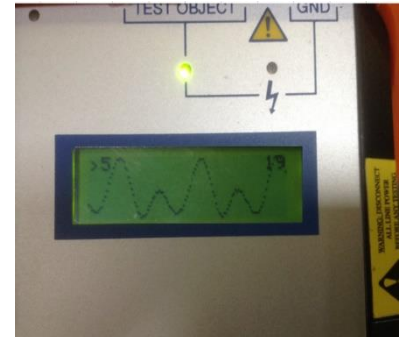
Figure 2 Manual Rotor Test

A manual rotor test performed using the ALL-TEST PRO 31™, this patented test displays the response of an injected AC signal to one phase of the motor windings as the shaft is smoothly and slowly rotated. A good rotor should provide a symmetrical waveform with rounded peaks. The non-symmetrical response displayed in Figure 2 indicates a rotor issue. Because the AT31™ rotor test indicated rotor issues, the plant then performed a more detailed rotor inductance test.

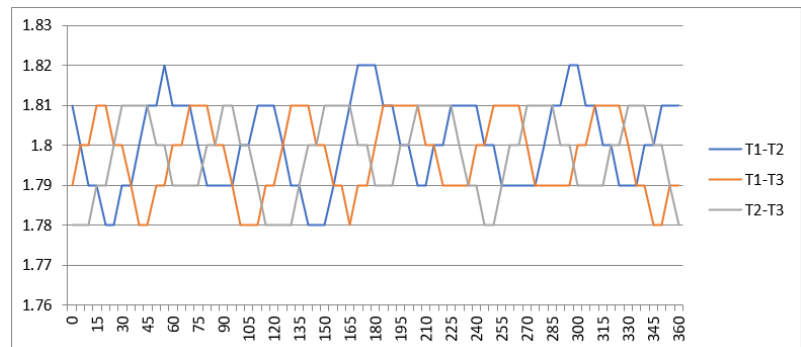
The rotor inductance test plots the inductance of all three phases as the shaft is repositioned in 5° increment. A good rotor again should present three identical waveforms. The waveforms don't need to be sinusoidal but should be symmetrical. The non-symmetry of the wave shapes indicates rotor faults such as cracked, broken rotors bars, casting voids or rotor eccentricity. The display plotted in Figure 3 indicates a rotor issue, but did not pinpoint the problem.

Figure 3 Rotor Inductance Test

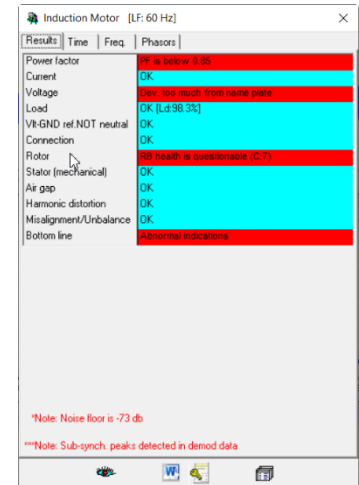
The ESA software uses proprietary algorithms to identify specific faults in the motor system and provides a detailed condition analysis of the incoming power, the electrical distribution system, the motor, the coupling, the driven machine and the process. The results screen provides a quick summary of the entire motor system. At a glance the color-coded screen highlights areas of concern in the motor system based on the automatic analysis. The results screen from motor 5 in Figure 4 indicates rotor bar health issues with a severity level C7, out of 7, there is a low power factor, excessive variations in both voltage and current but more importantly the “Bottom Line” is the motor is exhibiting abnormal indications.

Figure 4 Results Screen showing severe rotor bar damage

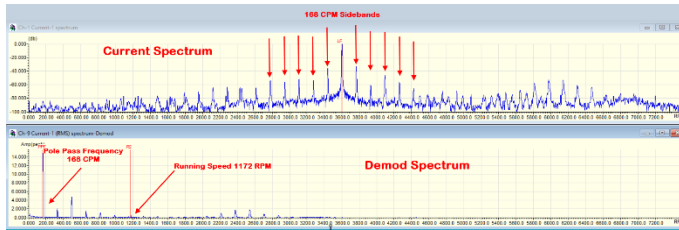
Figure 6: PPF side bands and reduced running speed 1172 RPM

The rotor condition is evaluated using five proprietary indicators that very accurately grade the rotor's condition. However, the most prominent indication of rotor issues are PPF side bands around line frequency (pole pass frequency = # poles times slip speed). Figure 5 displays the low frequency current spectrum has

multiple PPF side bands around the line frequency peak. This is one of the strongest indications of rotor bars issues—the lower portion of the Figure 5 spectral display is the demod spectrum. The demod spectrum directly displays the spectral peaks of any frequency or frequencies that is modulating the current. The demod spectrum displays frequencies as they would be displayed in most vibration spectral displays. The resolution of the low frequency display has 6000 lines of resolution so the frequencies can be determined within 1.2 CPM, which is very important since it allows the actual running speed of the motor to be very accurately determined. The ESA software annotates important peaks in the displays. The demod spectrum marks running speed at 1172 RPM with the PPF at 168 CPM. The PPF is calculated by [# poles (6) times slip speed]. {Slip speed = Synchronous speed (1200) – Running speed (1172)} is there PPF equals  $1200 - 1172 = 28 \times 6 = 168$  CPM. When these 2 peaks in the demod spectrum align it pretty much that the calculated running speed is correct which confirms the analysis is accurate and correct. The actual running speed was confirmed by the vibration technician using a hand-held tachometer to measure the actual shaft speed. It is also important to note that the actual running is 13 RPM below nameplate, which is consistent with rotor bar issues.

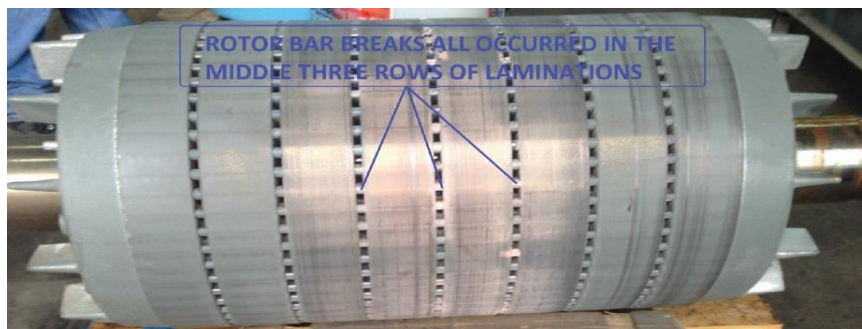
Figure 8 Pump 5 rotor as found

The visual inspection of pump 5 motor found that over 30% of the rotor bars were broken or damaged. All the damage on the rotor bars were in the center of the rotor, which generally indicates thermal expansion issues. (Rotor Bars cracked at the end rings suggests torsional issues caused by static eccentricity).

After discussions between the motor manufacturer and the repair facility, it was decided to replace the existing aluminum rotor bars with copper bars on both pump motors. As expected, the inspection of the motor 1 found similar damage to the rotor bars, but only 25% of the bars were damaged. During the rebuild of motor 5, the upper bearing was replaced, but a visual inspection of the bearing found no damage, which is consistent with an early stage 2 bearing defect.

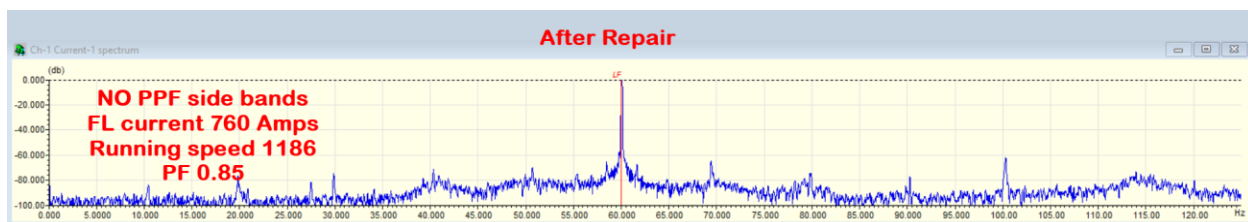
After the rotor bars were replaced with copper rotor bars additional ESA and vibration data were taken, the average overall vibration levels decreased from 0.088 ips to 0.068 ips. The motor speed increased from 1172 to the nameplate value 1186 RPM, motor current decreased to below nameplate 760 Amps, there were zero pole pass frequency side bands and the motor PF returned to nameplate. More importantly the rotor severity condition improved to C1: Excellent condition.
